**ANALYSIS OF HISTORICAL DISTRIBUTION OF SUBMERGED AQUATIC VEGETATION
(SAV) IN THE YORK AND RAPPAHANNOCK RIVERS AS EVIDENCE OF
HISTORICAL WATER QUALITY CONDITIONS**

Special Report No. 375 in Applied Marine Science and Ocean Engineering

December 2001

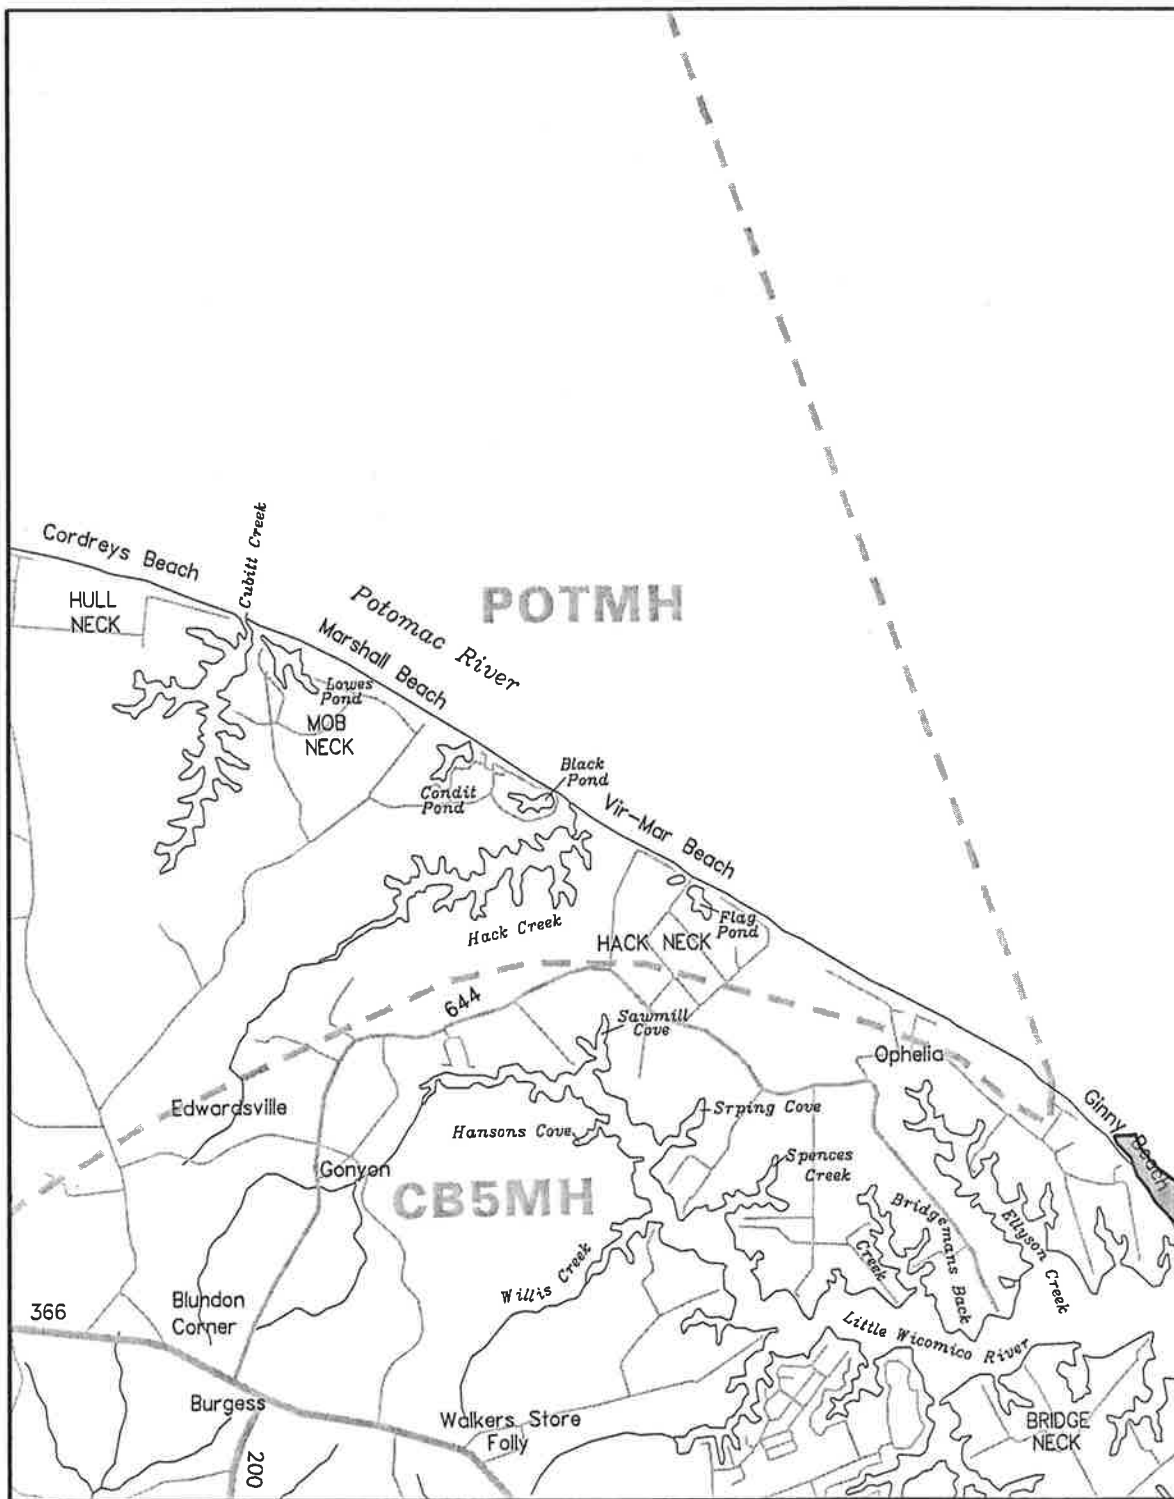
Burgess, Va.- Md. (098)

Hectares of SAV: 18.50

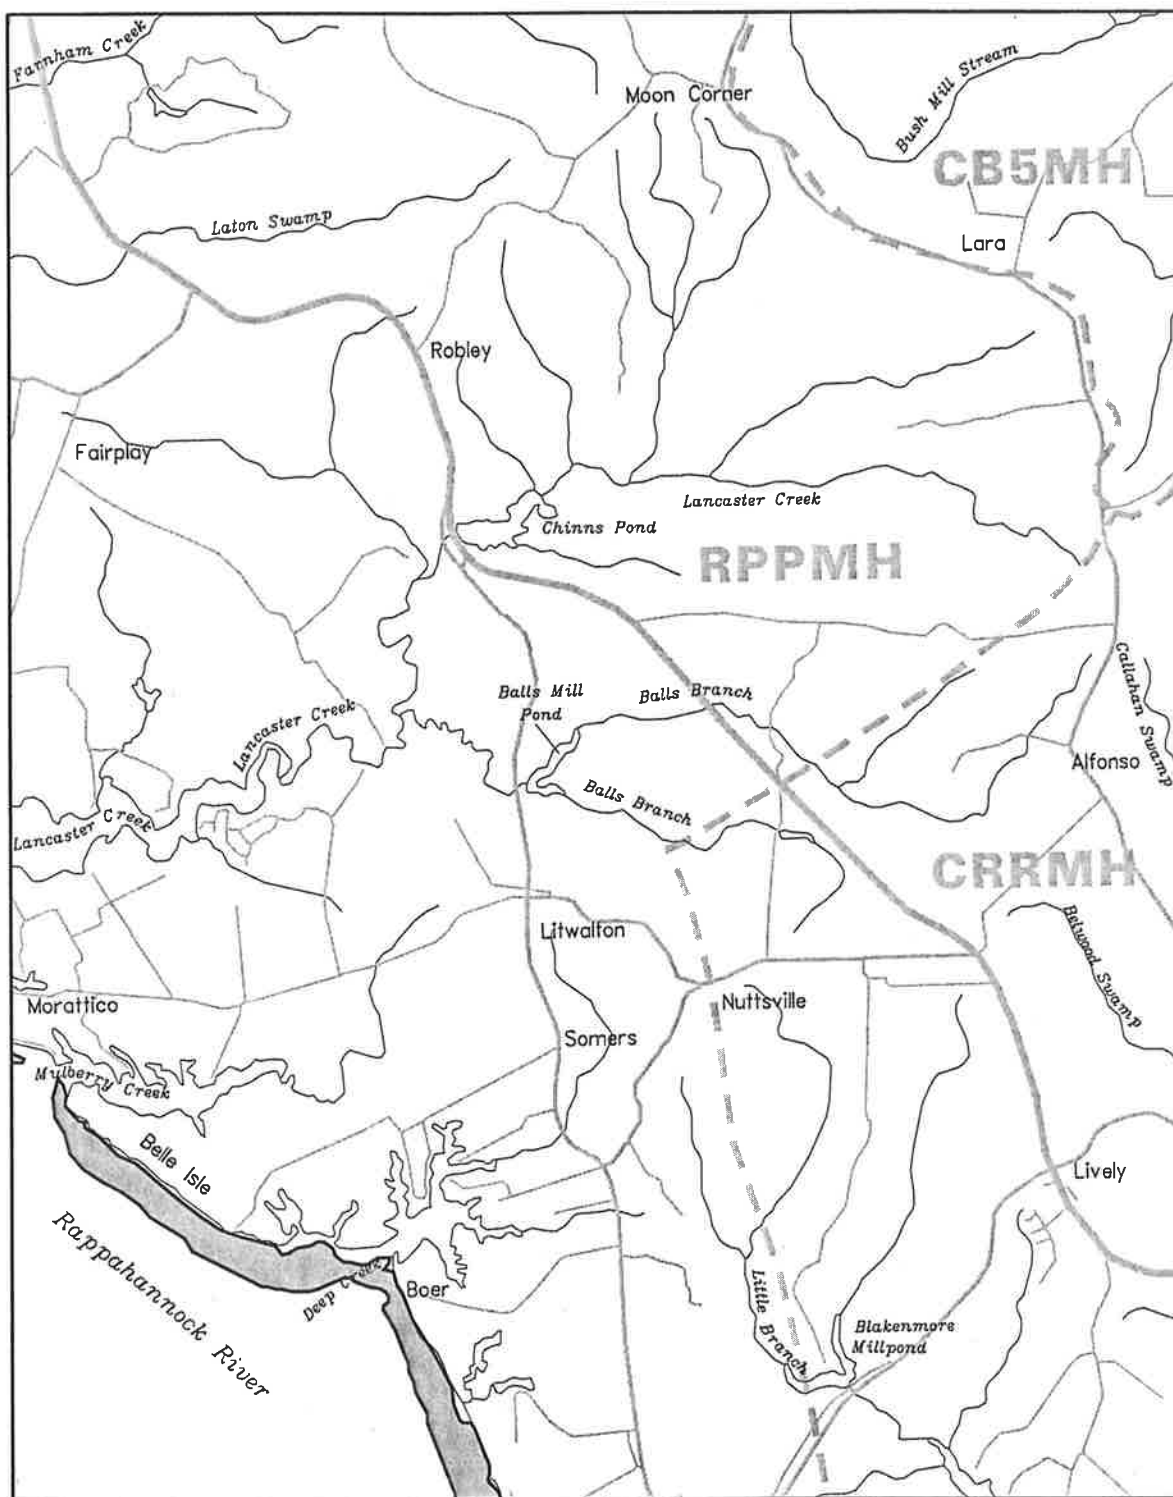
Lively, Va. (105)

Hectares of SAV: 173.22
