Recommendations for Verifying Individual Stream Restoration Projects

Tom Schueler and David
Wood
Chesapeake Stormwater
Network

April 16
USWG Meeting

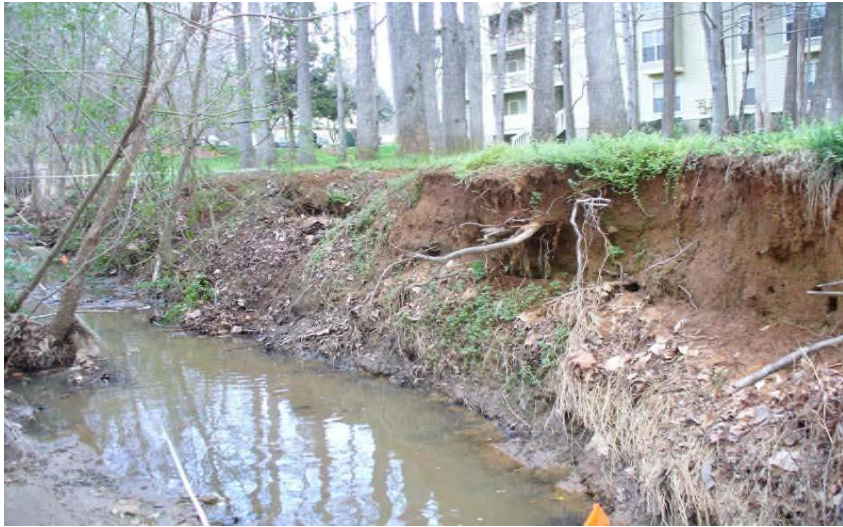
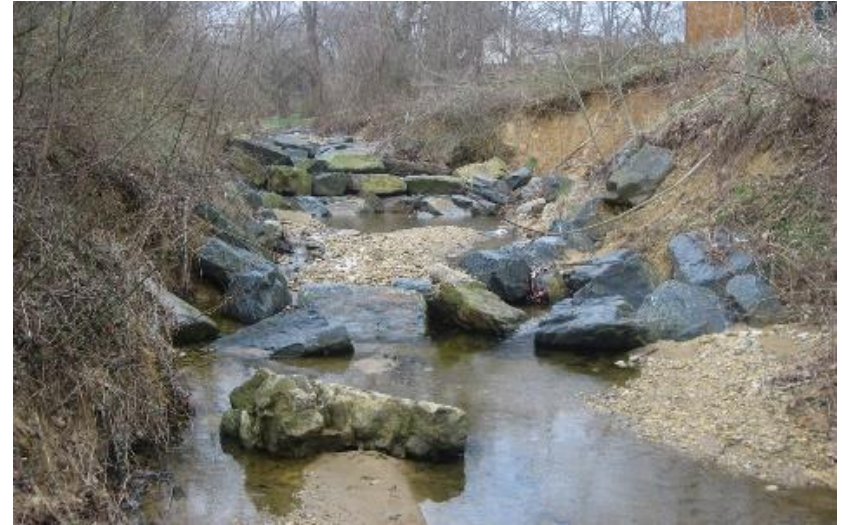
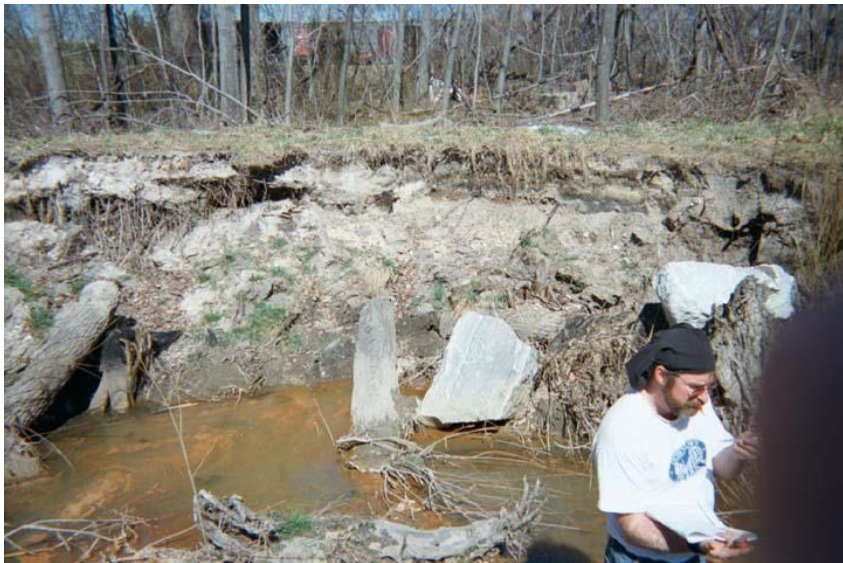
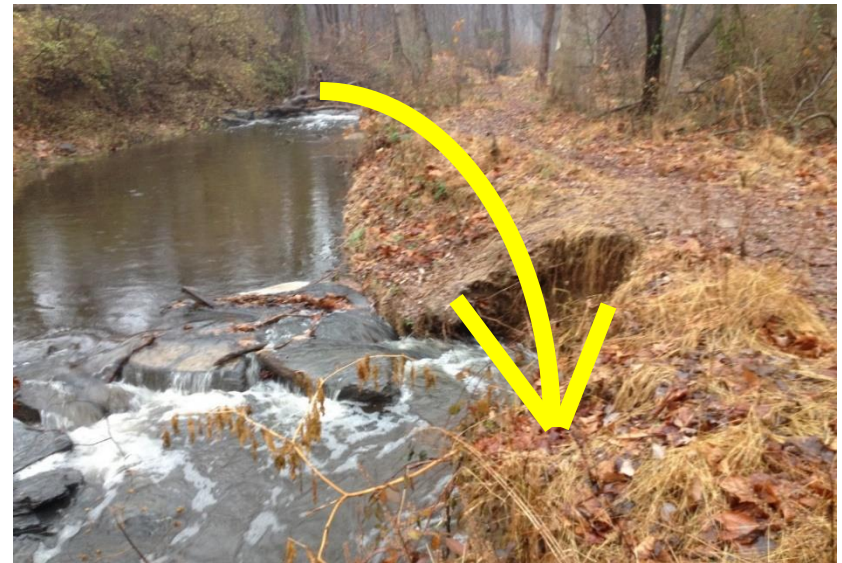
Examples of Visual Indicators for Protocol 1

Criteria for Loss	Key Visual Indicators
Evidence of bank or bed instability such that the project delivers more sediment downstream than designed, as defined by exposed soils/fresh rootlets	<ul style="list-style-type: none">• Severe bank erosion (bare earth exposed or extreme undercutting)• Departure of more than 20% from average post-construction design bank height ¹• Incising bed (bed erosion resulting in the loss of defined pools and riffles and/or presence of active head cut)• Flanking or scour of in-channel structures• Failure or collapse of allowable bank protection practices• Less than 80% ground or canopy cover in the restoration zone ²

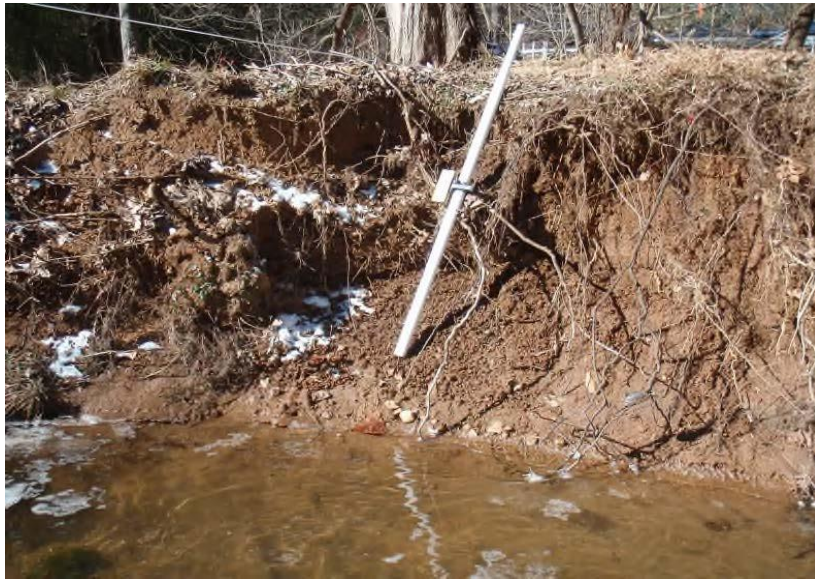
Clear indicators that indicate severe problems that field technicians can agree on

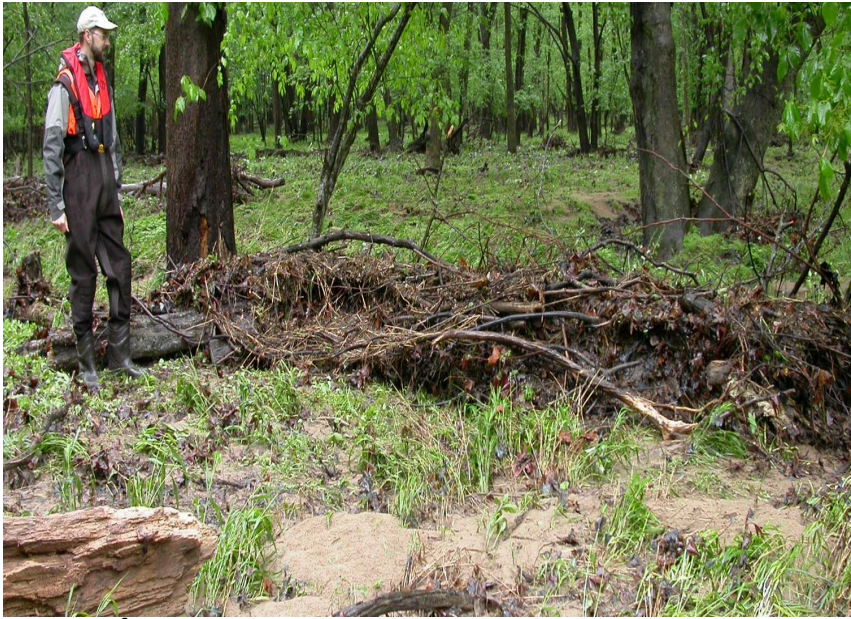
Visual Indicators for the hyporheic box and floodplain

Criteria for Loss	Key Visual Indicators
Evidence that the reach is no longer fully meeting the design assumptions for expanding the hyporheic box (such as when channel incision reduces access to hyporheic zone)	<ul style="list-style-type: none">• Departure of more than 20% from average post-construction design bank height ¹• Observable aggradation in streambed (as measured by embeddedness, loss of riffles or bed heterogeneity or excessive deposition, such as lateral and mid-channel bars)• Less than 80% ground or canopy cover ² found in the project's designed hyporheic zone ³• Stream de-watering (lack of any observable baseflow in the stream channel)

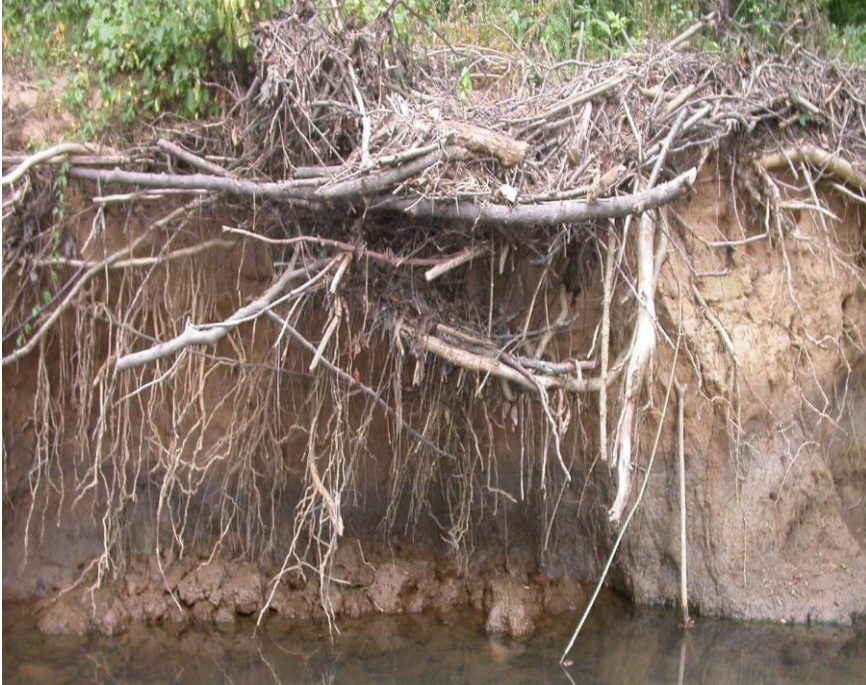
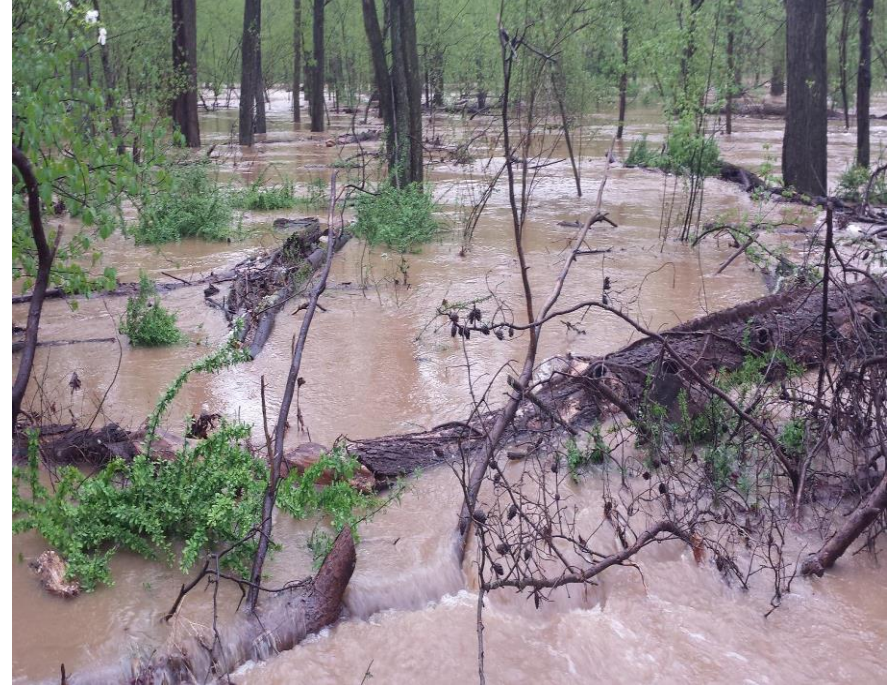
Bank and floodplain connection indicators are critical for Protocol 3

Criteria for Loss	Key Visual Indicators
Channel incision or floodplain sediment deposition increases effective bank height, thereby reducing intended annual stream flow volume diverted to floodplain	<ul style="list-style-type: none"><li data-bbox="749 434 1862 601">• Departure of more than 20% from average post-construction design bank height ¹ or presence of active head cuts<li data-bbox="749 615 1862 729">• Features used to divert flows to or from floodplain are obstructed and no longer work<li data-bbox="749 743 1862 911">• No evidence of floodplain retention, as signified by a lack of sediment deposition, terraces, wrack-lines or leaf clumps in floodplain<li data-bbox="749 925 1862 1029">• Unable to meet intended wetland or tree canopy cover targets with the project floodplain ²
