Tidal Water Quality Status and Trends

Aquatic Conditions Respond to Watershed Changes

CBP Principle Staff Committee Meeting
Baltimore, MD
March 2, 2018

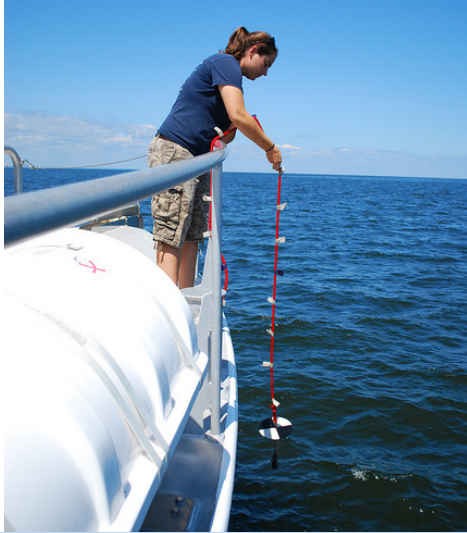
Water quality data are collected at 150+ locations in tidal waters throughout Chesapeake Bay. Long-term monitoring stations have been visited by boat 1 or 2 times per month every year since 1985.

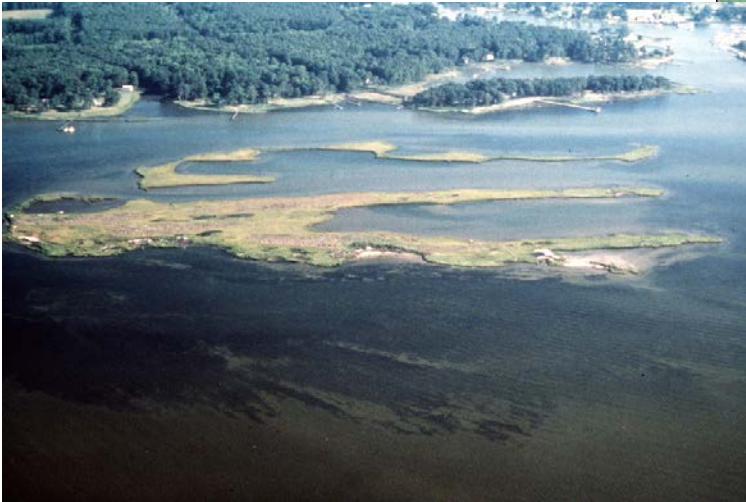
Over 187 flight lines are flown each year to track loss and recovery this important habitat. Baywide SAV abundance has been collected annually since 1984 by VIMS.
