Using Ecological Expertise and Assessment Data to Inform Functional Improvement in Urban Stream Restorations

Chris Ruck, Emma Gutzler, Matt Meyers
Stormwater Planning Division

A Fairfax County, VA, publication
June 2018

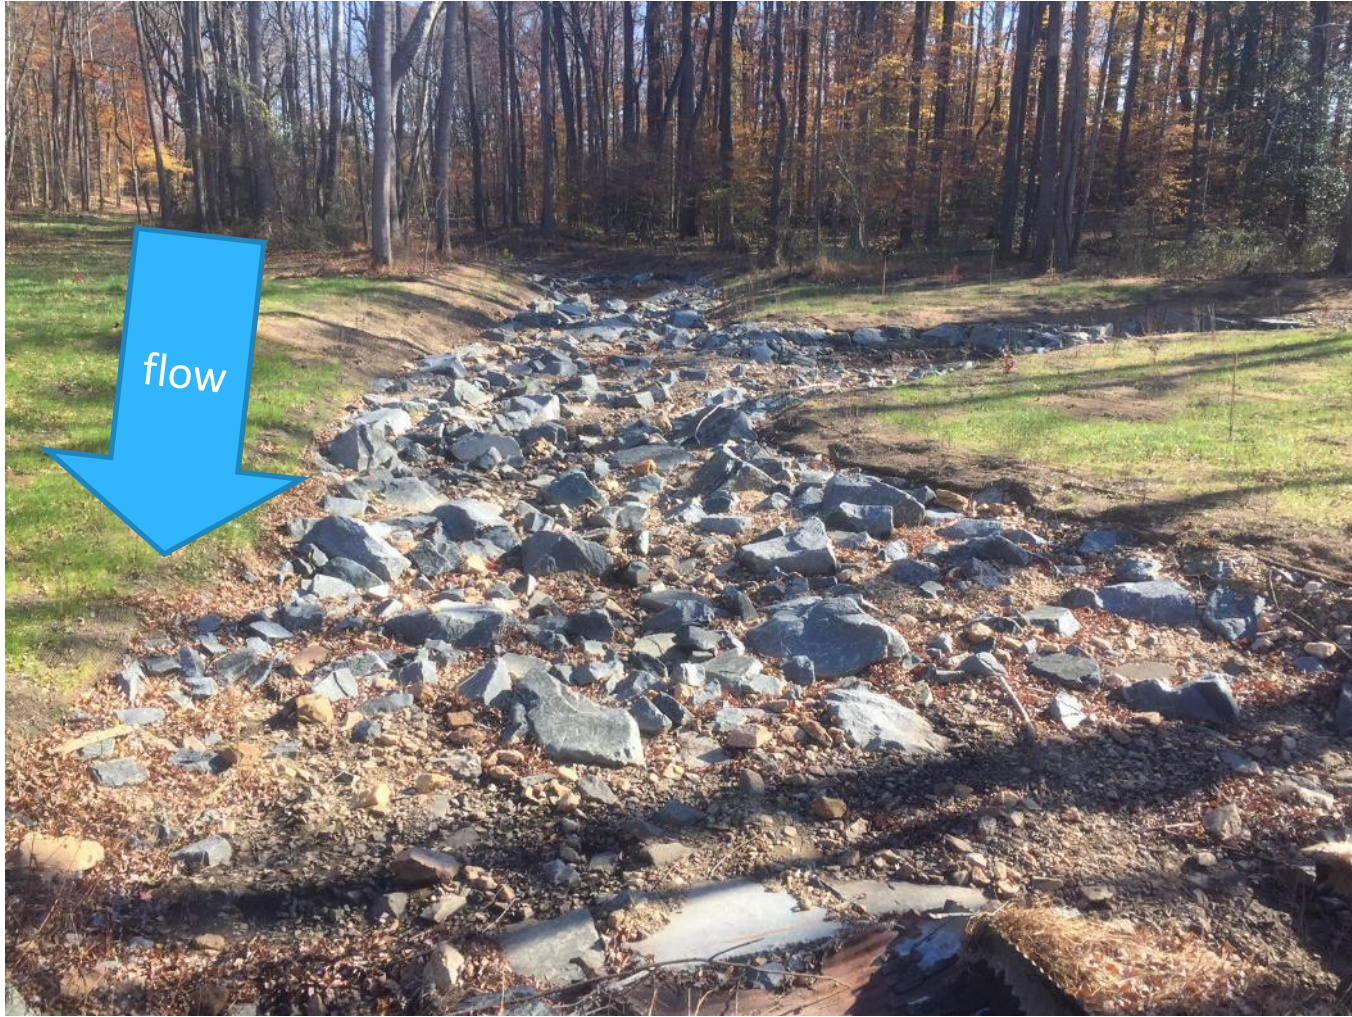
Actual
Thalweg

Design
Thalweg

Oversized Bed Material – Where did the stream go?

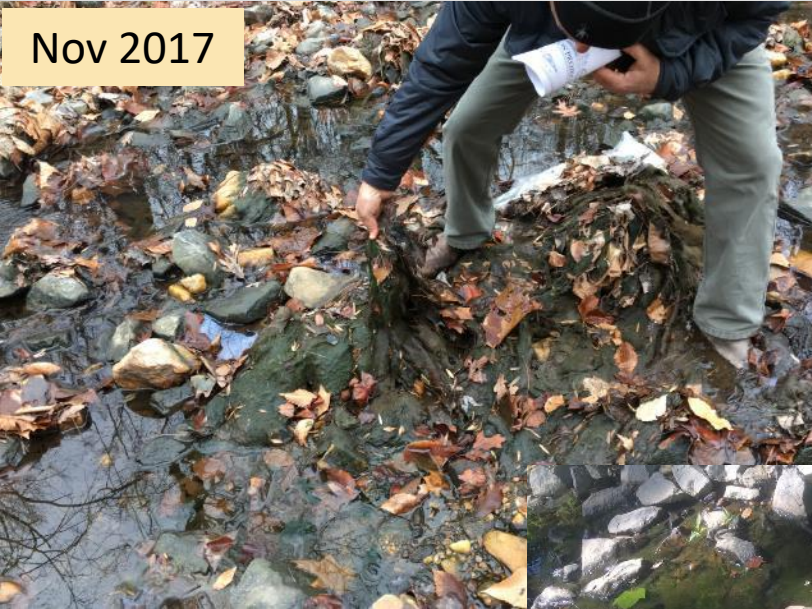
Open Canopy – Primary Production

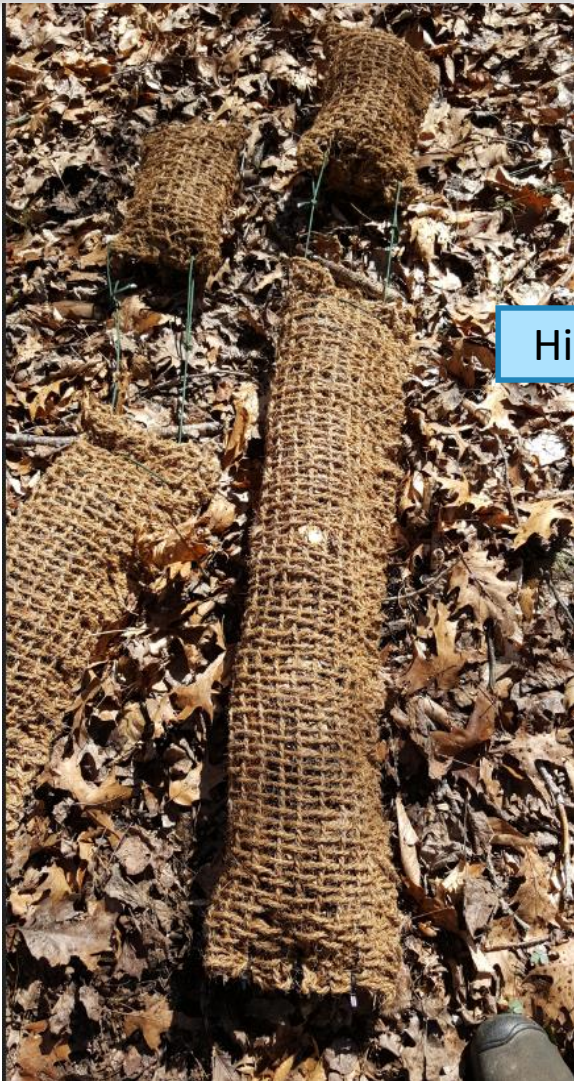
Habitubes Pilot Study - Design

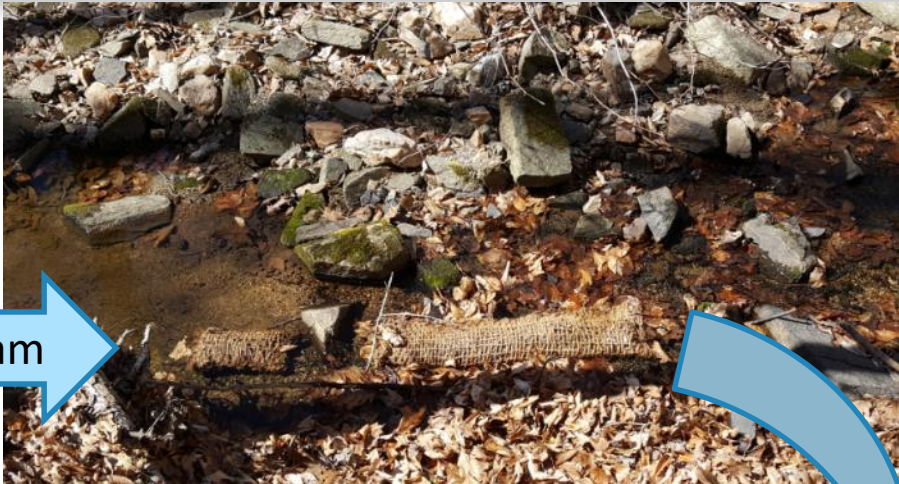
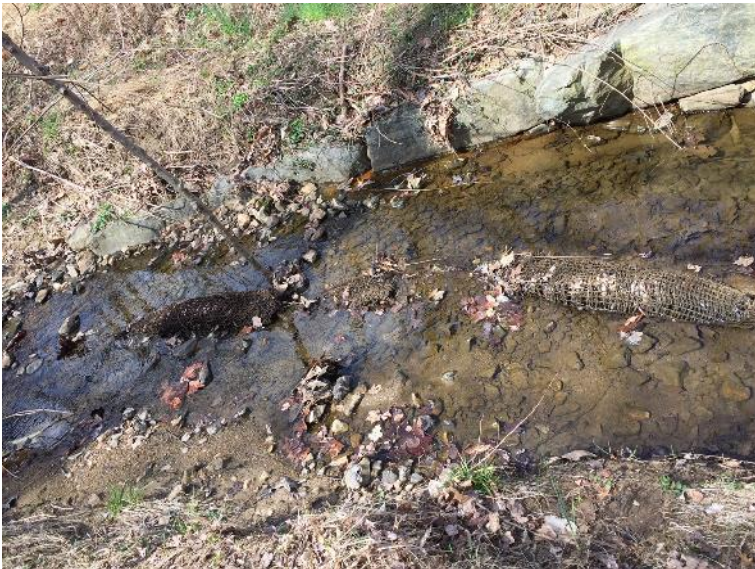
High Quality Stream

Transfer to Restored Stream

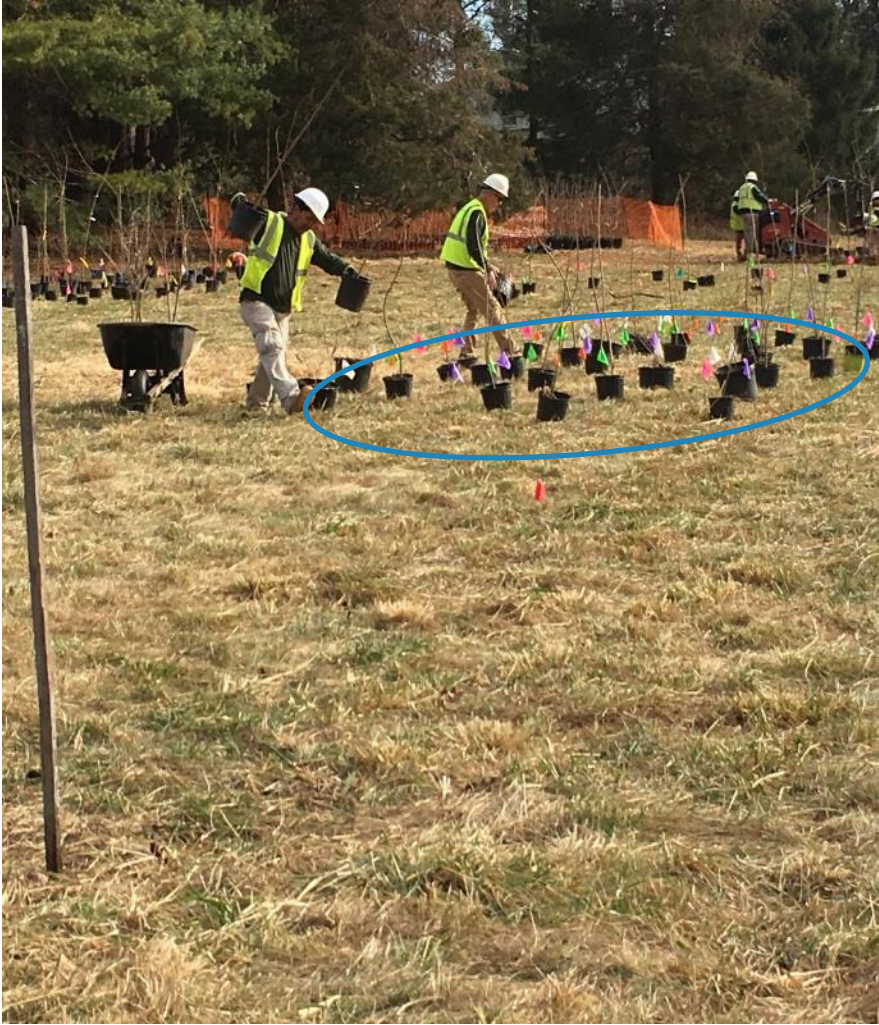
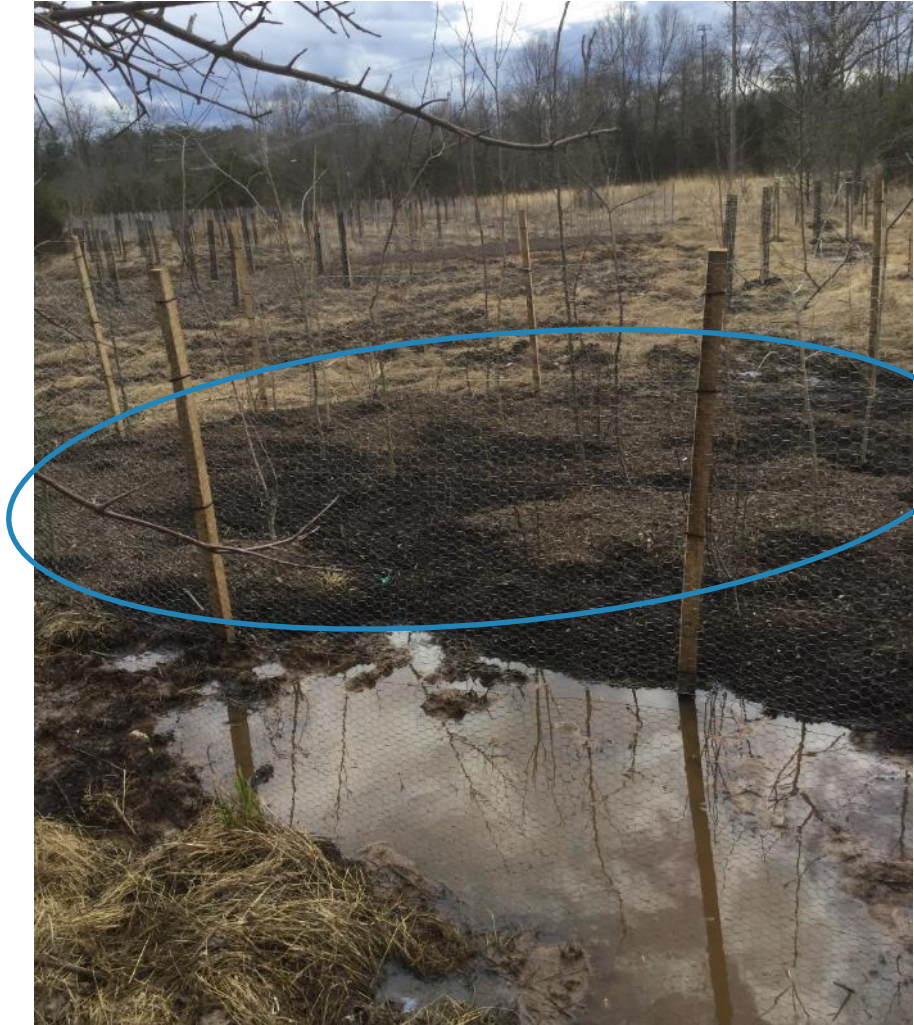
Planting (and Monitoring) Superclumps

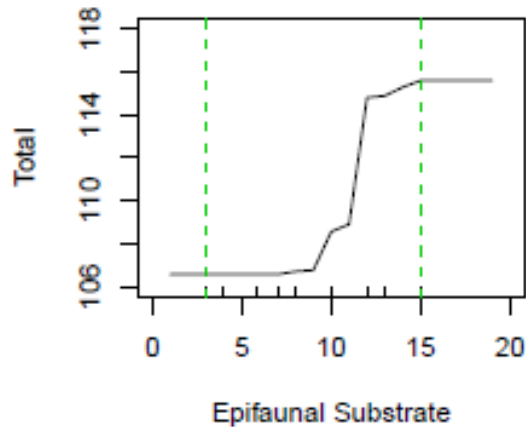
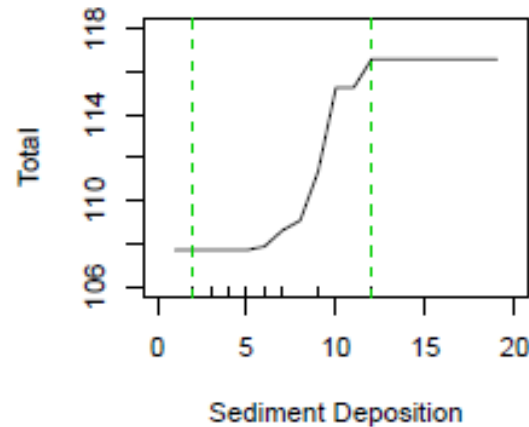
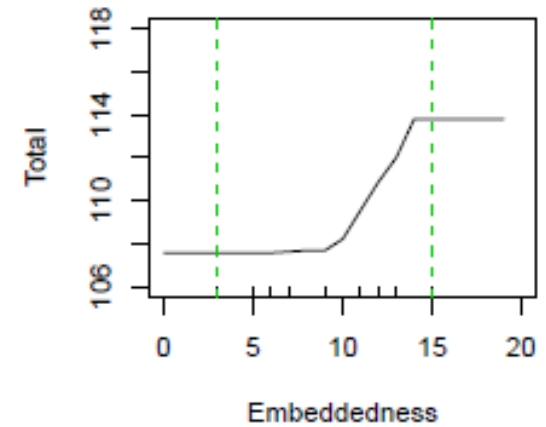
Habitat metrics vs. total habitat score

VERY INFORMATIVE

- Epifaunal substrate/
available cover
- Sediment Deposition
- Embeddedness

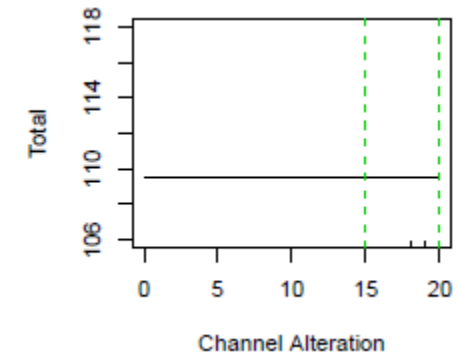
NOT INFORMATIVE

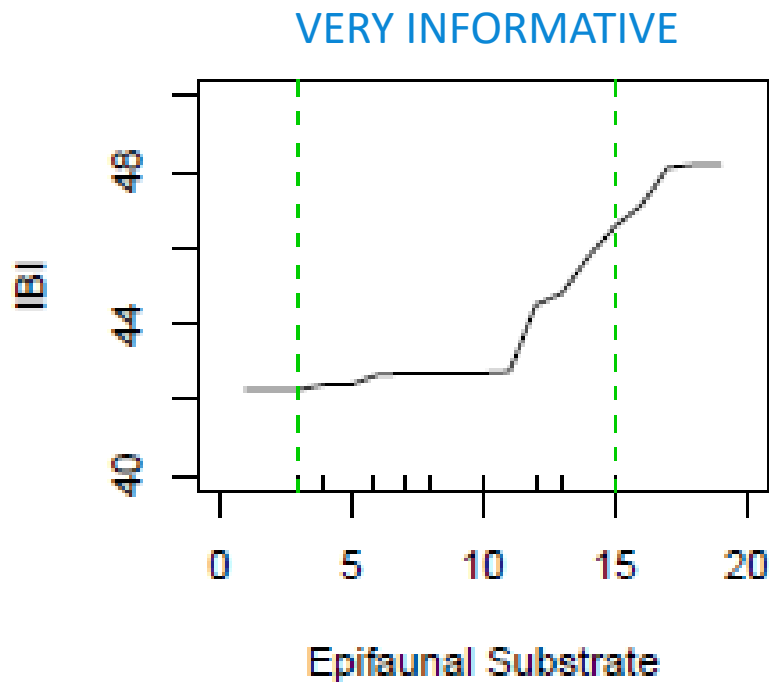
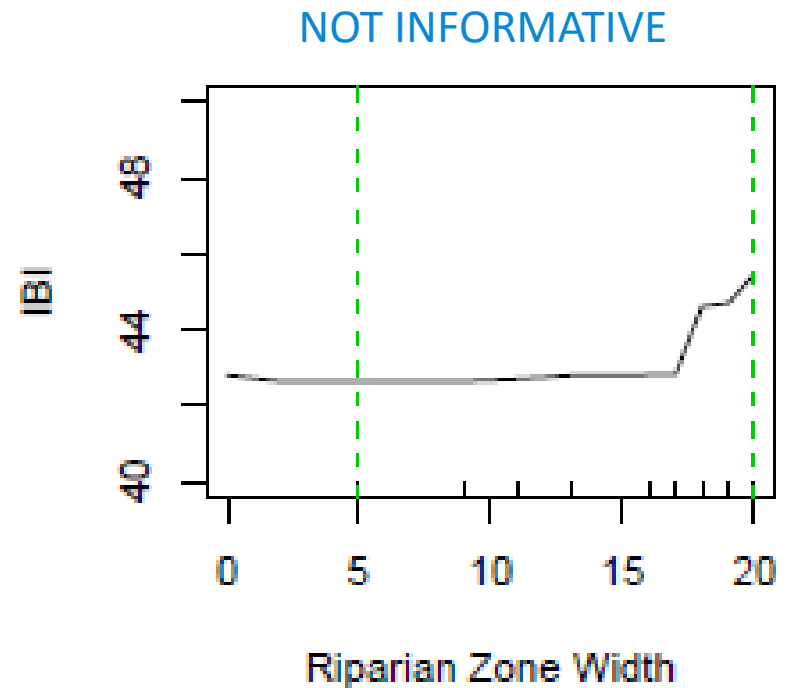
Habitat metrics vs. IBI score

- Same 3: Bed quality/available habitat

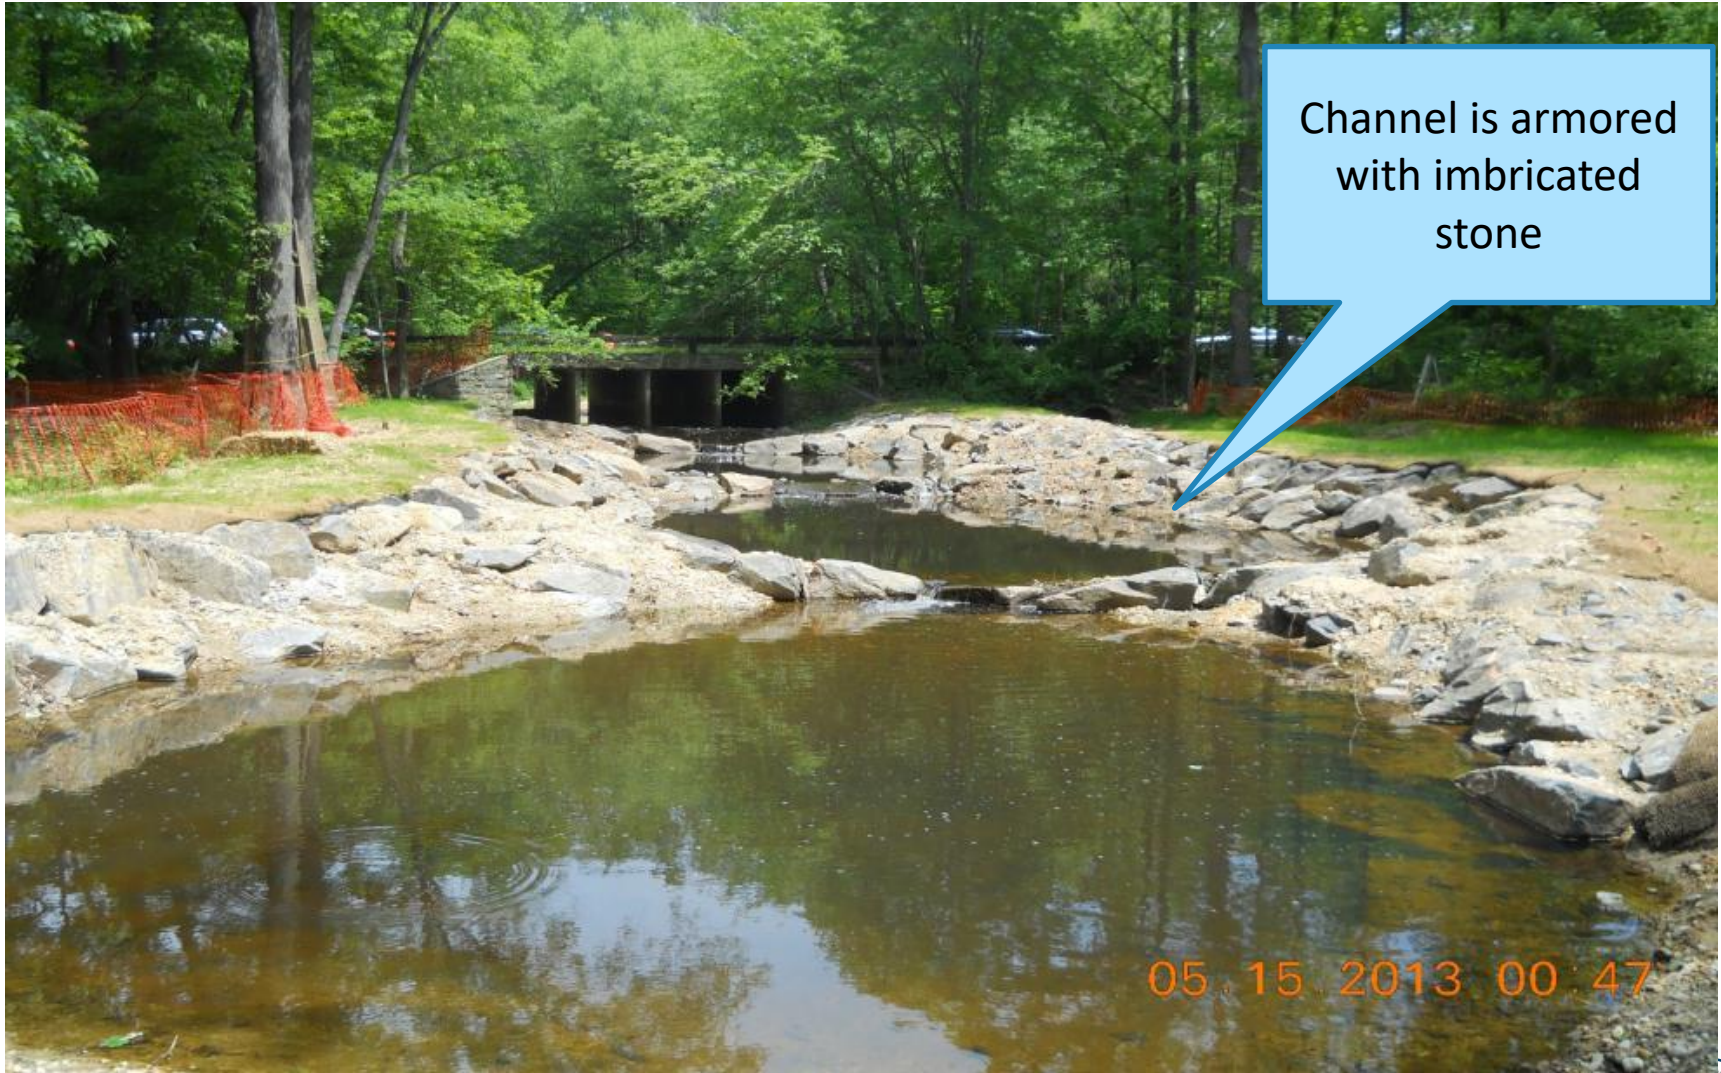
Uniform Channels – Armoring and Step Pools

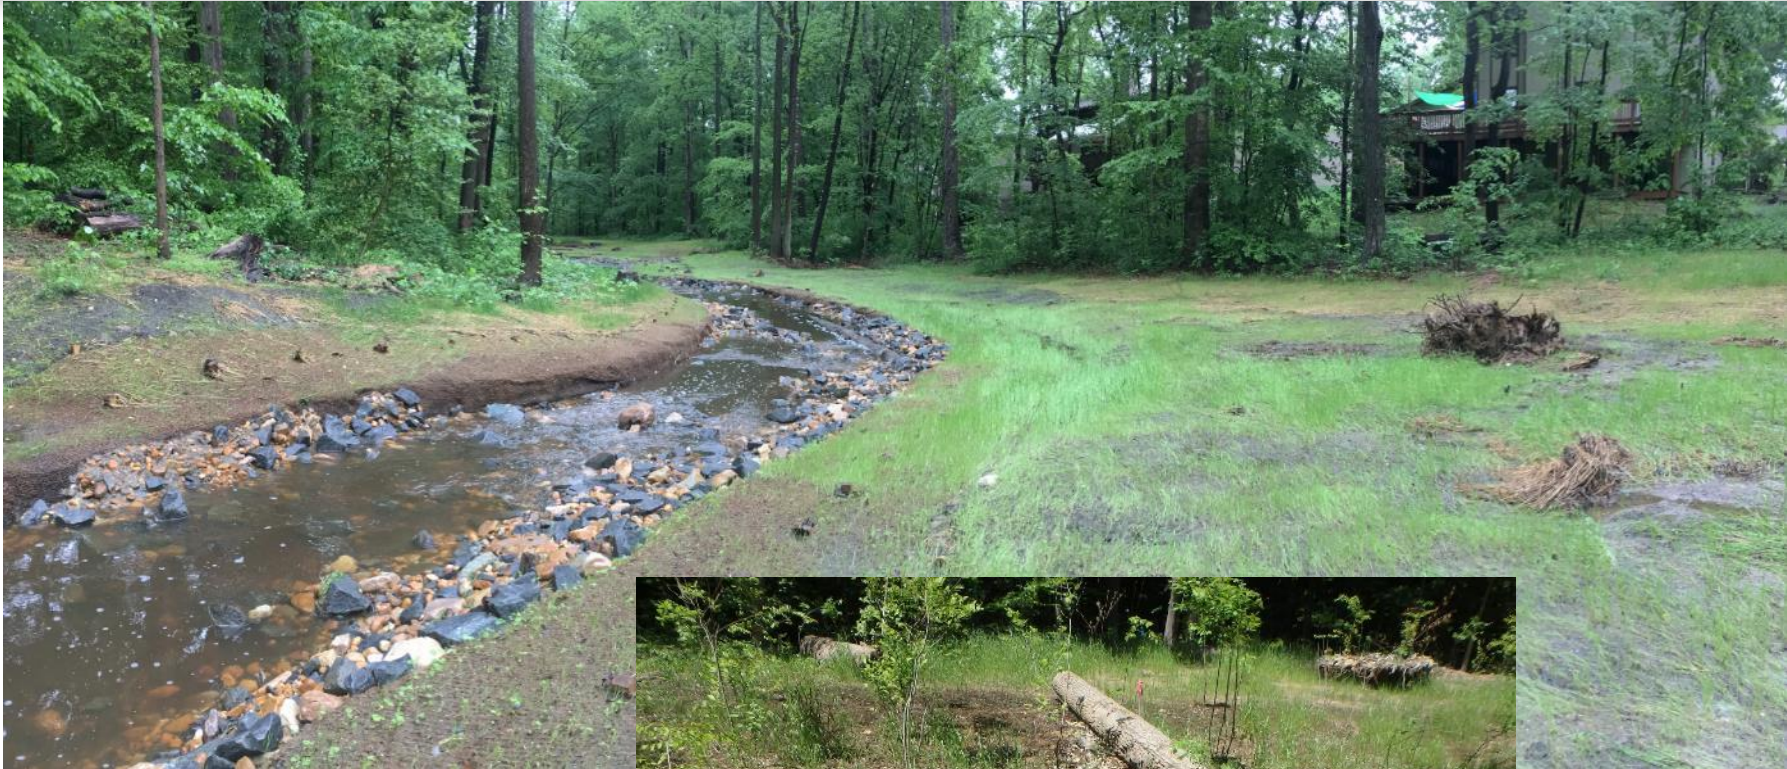
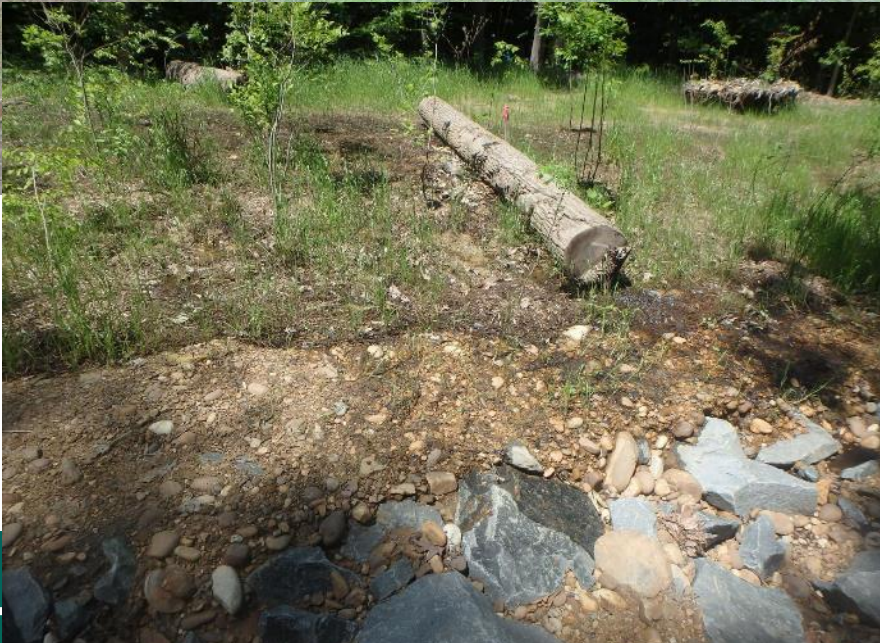
Floodplain Connectivity – New Designs

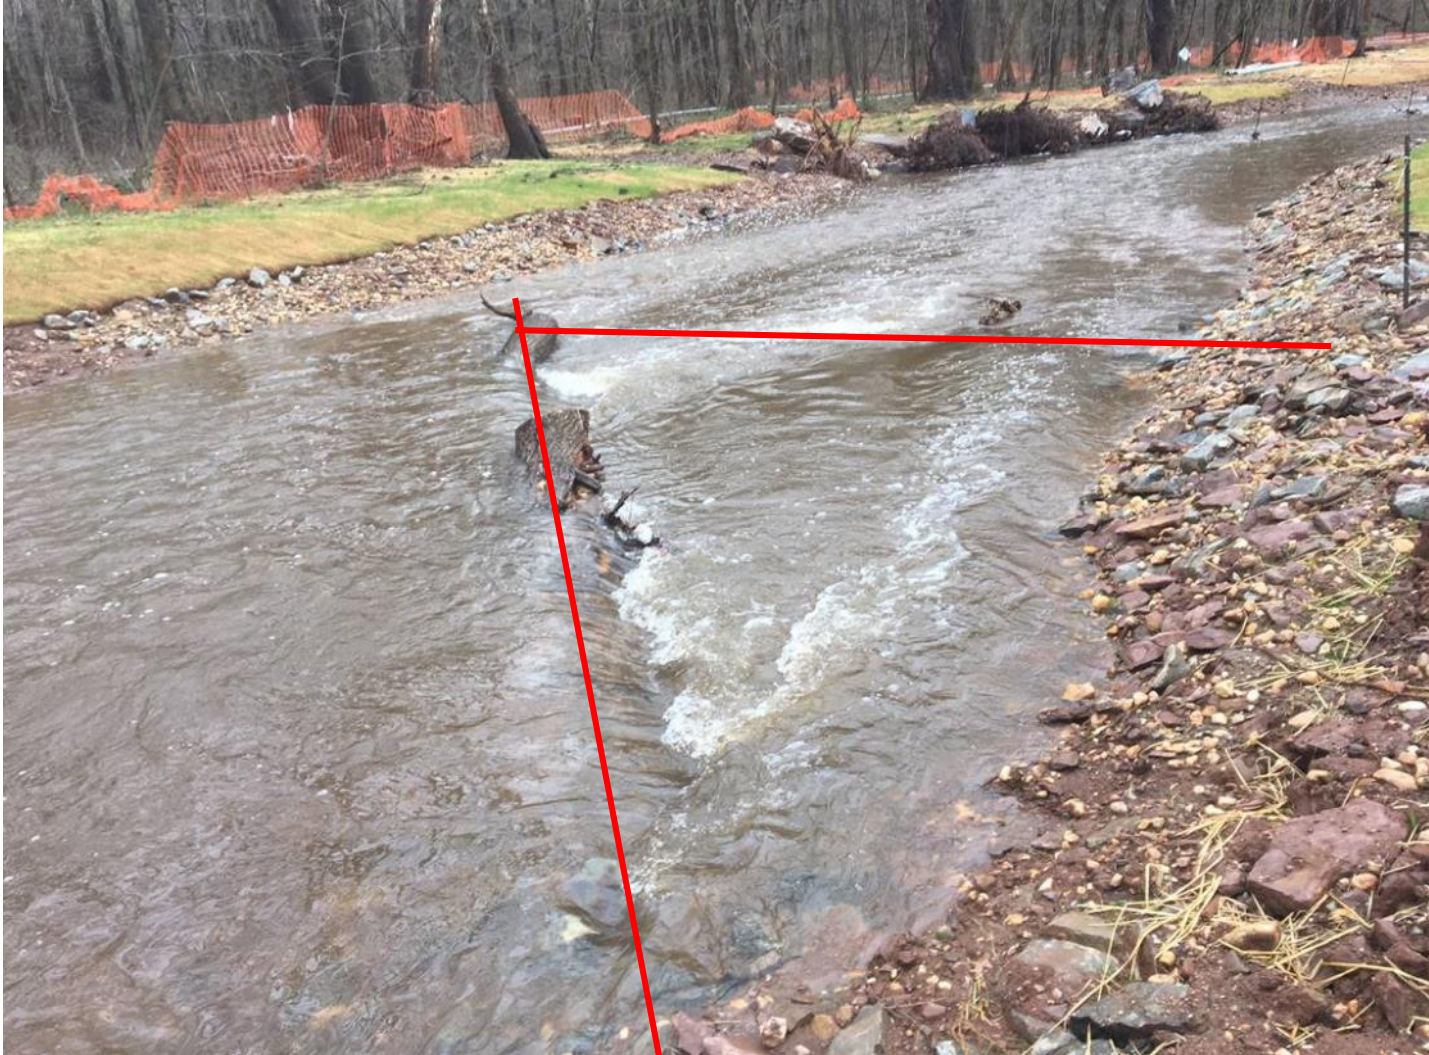
Restoration Large Woody Debris

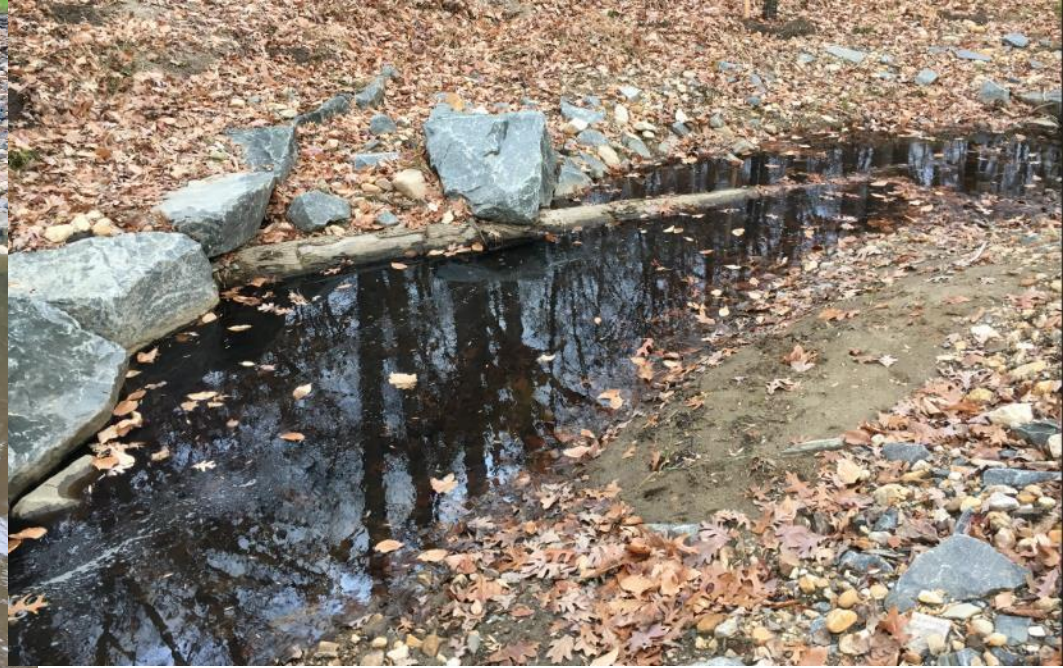
Cantilevered Toe Logs – Turkey Run @ Truro

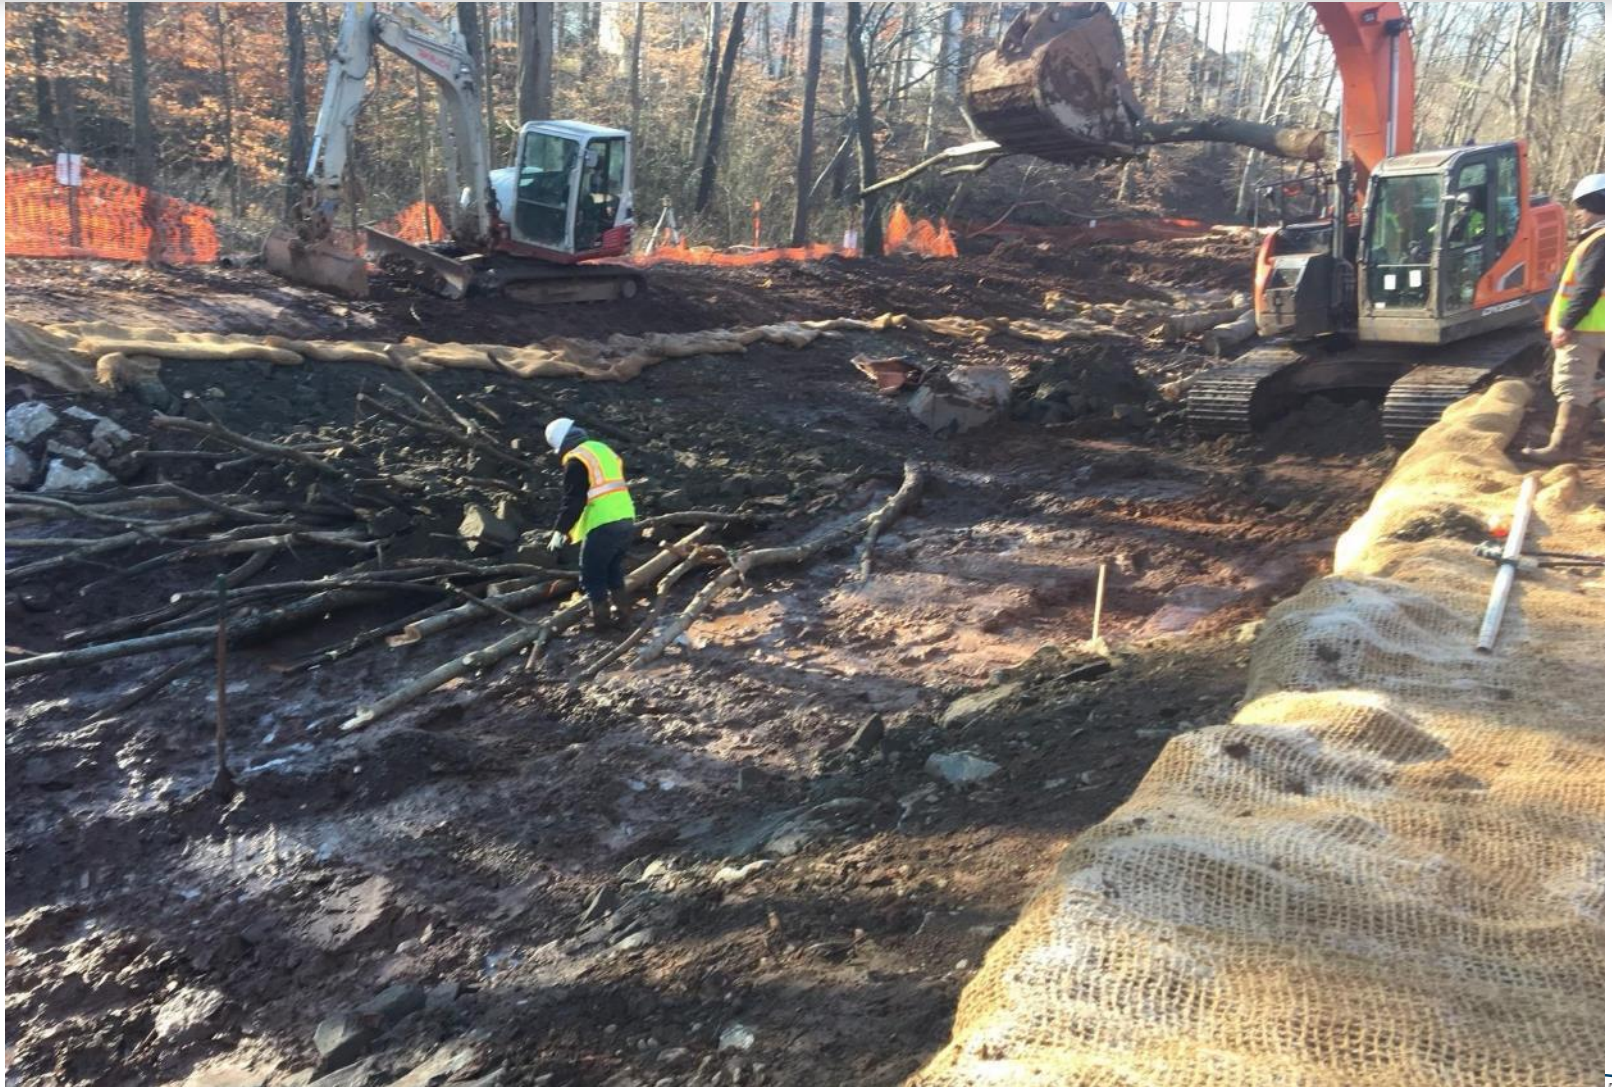
Type VI Riffle-Glide Woody Debris Installation

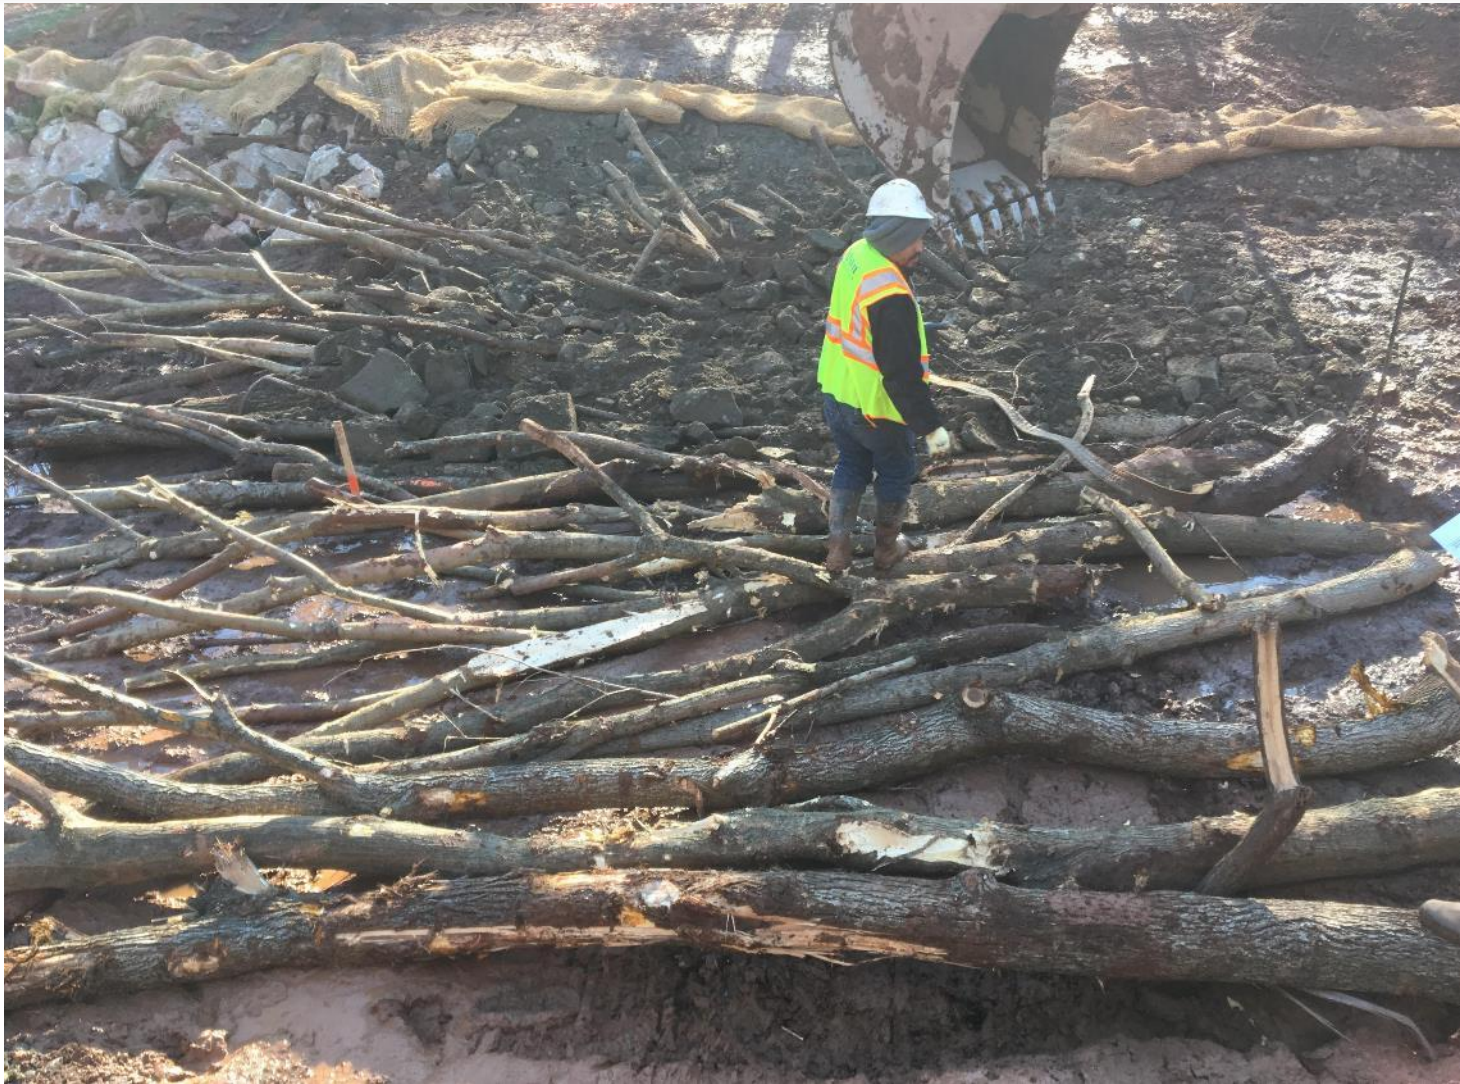
Type VI Riffle-Glide Woody Debris Installation

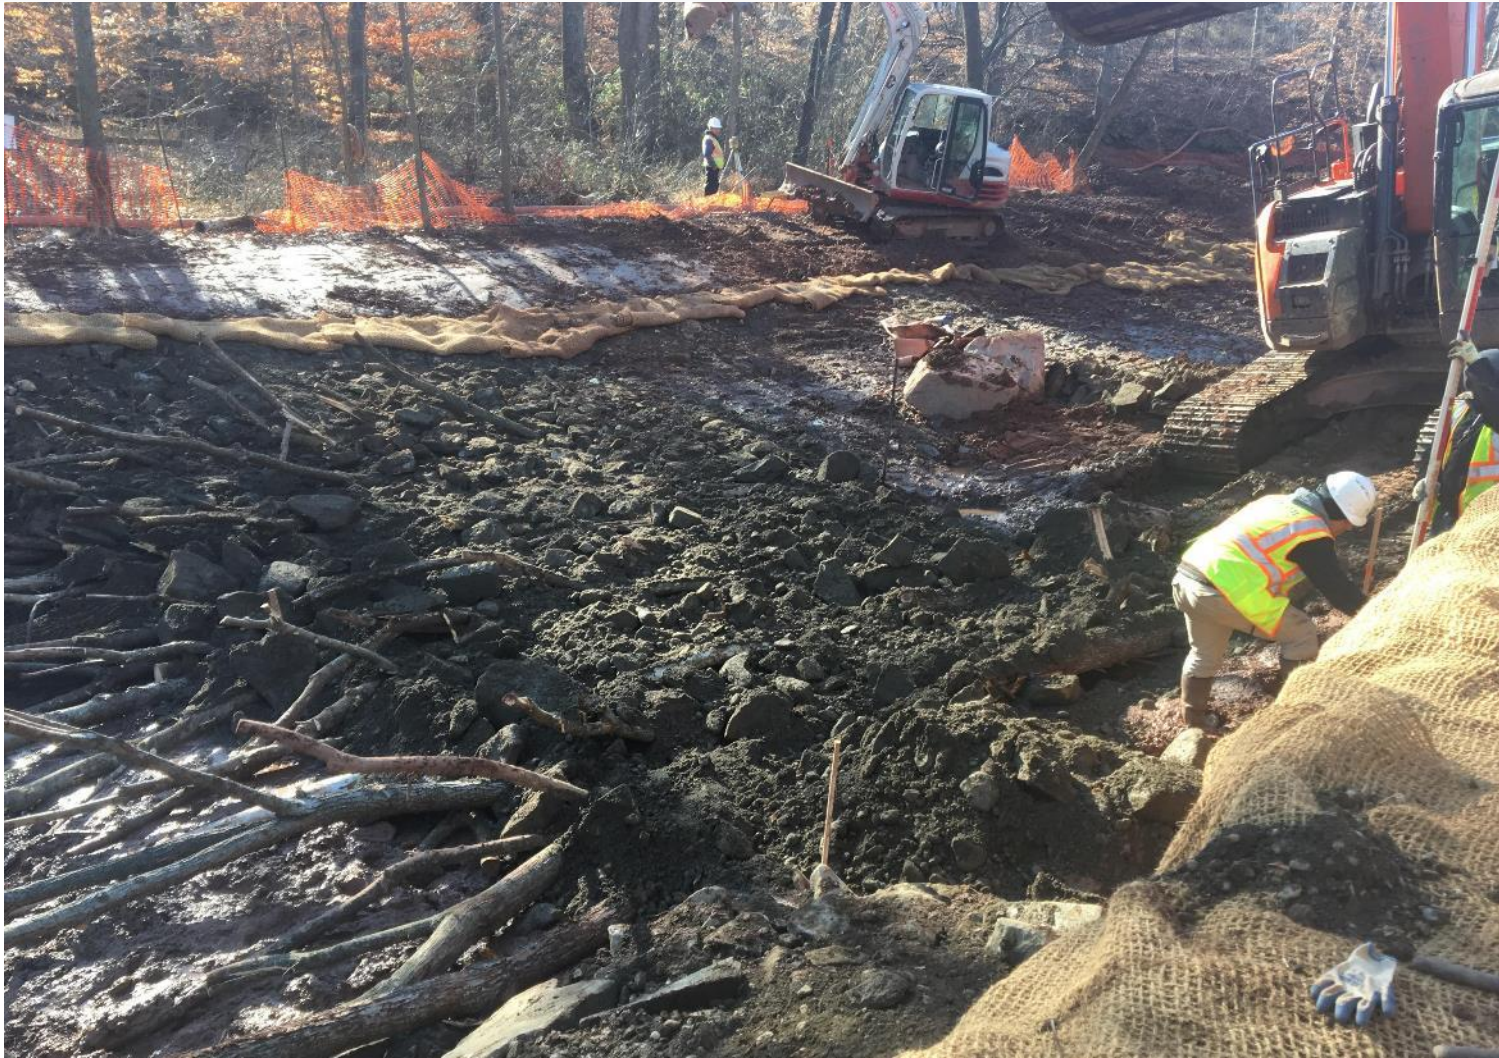
Type VI Riffle-Glide Woody Debris Installation

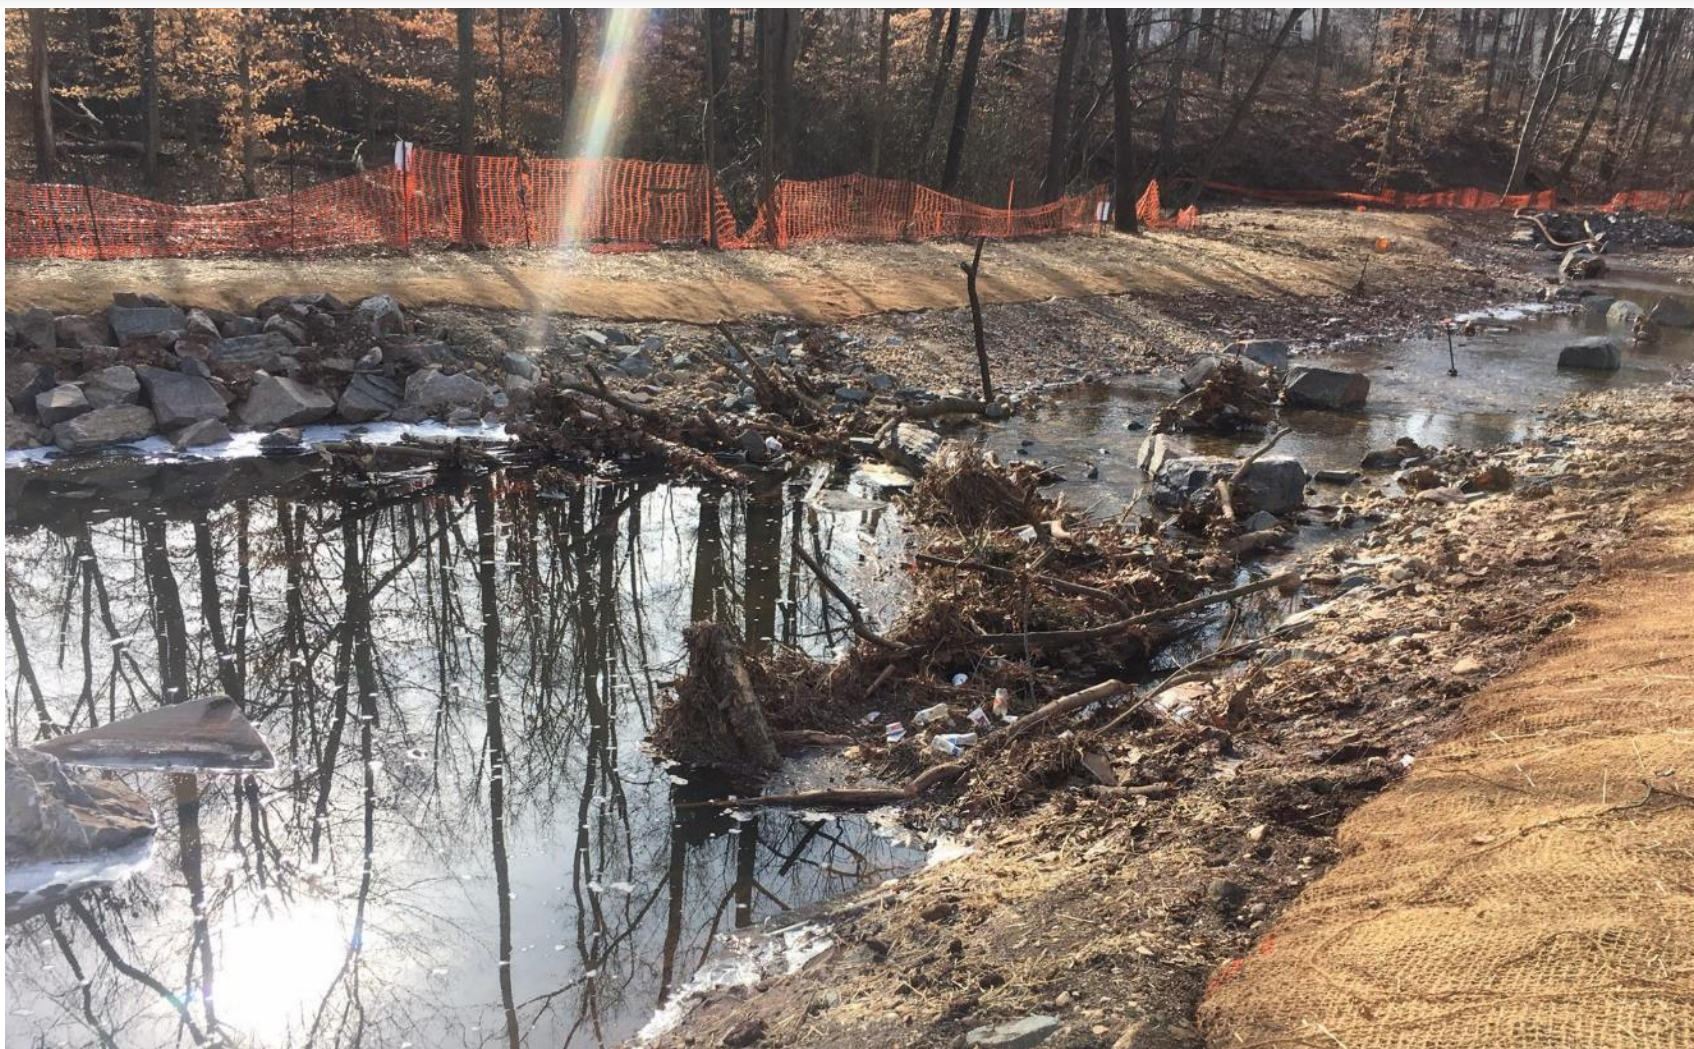
Type VI Riffle-Glide Woody Debris (3 weeks)

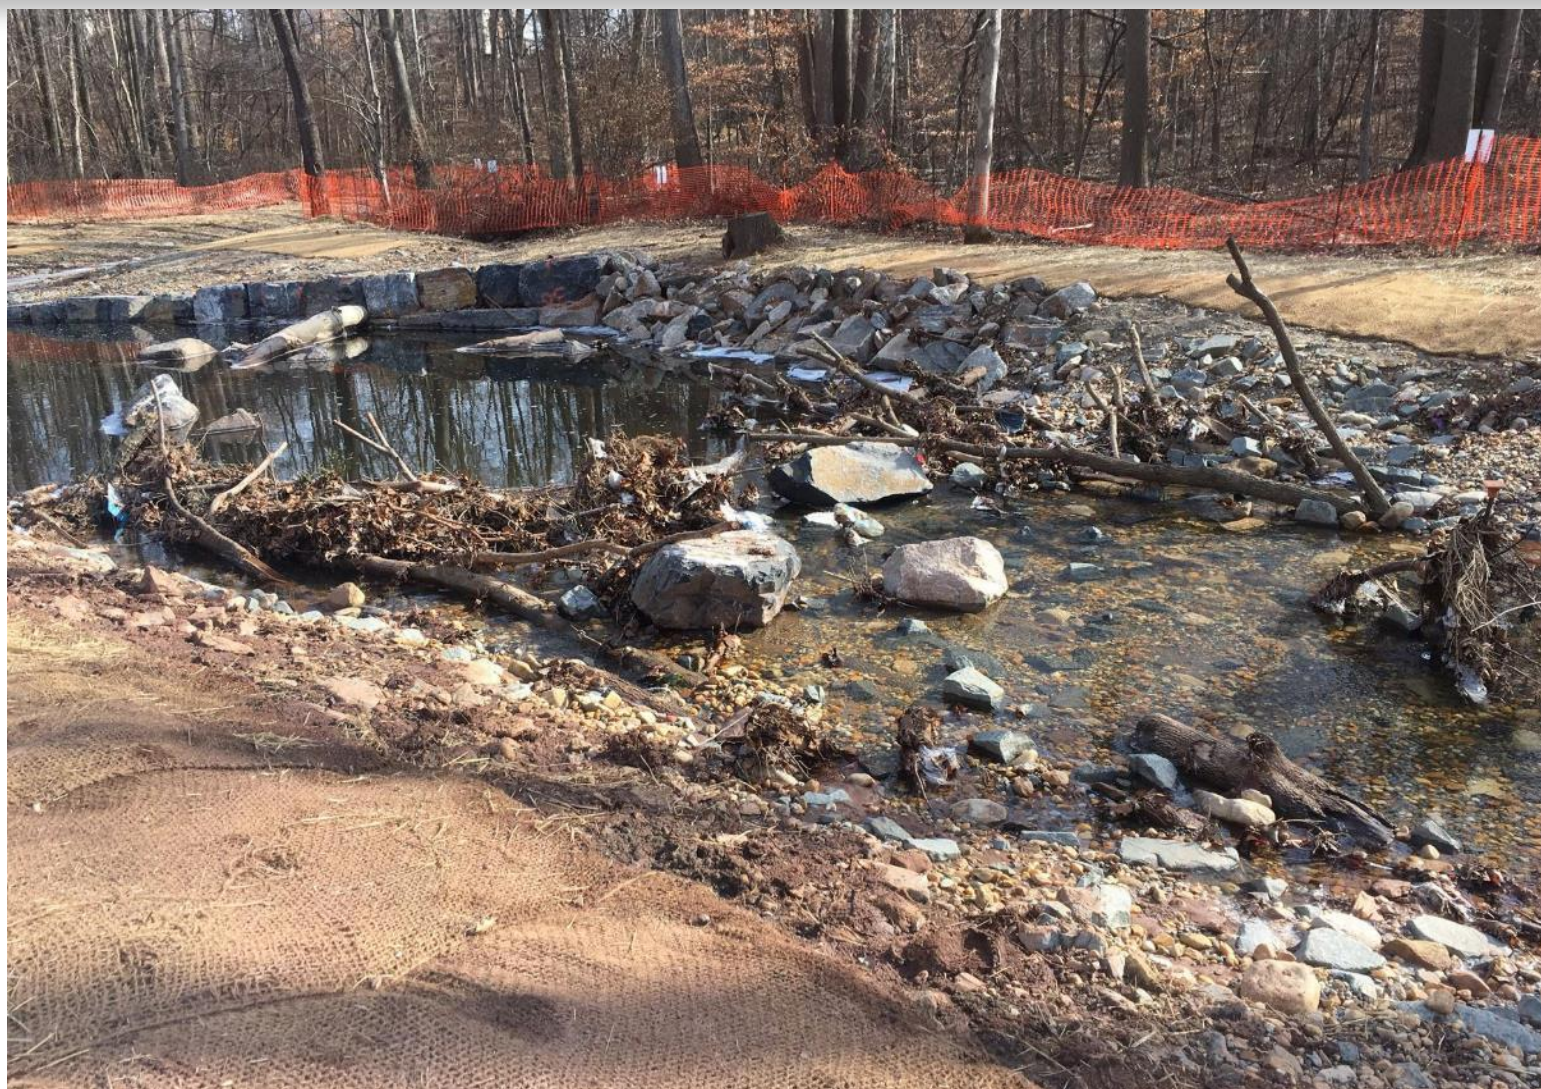
Type VI Riffle-Glide Woody Debris (3 weeks)
