Recommended Methods to Verify Stream Restoration Practices Built for Pollutant Crediting in the Chesapeake Bay Watershed

Submitted By: Stream Restoration Group 1: Verification

A Report to the Urban Stormwater Work Group

Date: April 10, 2019

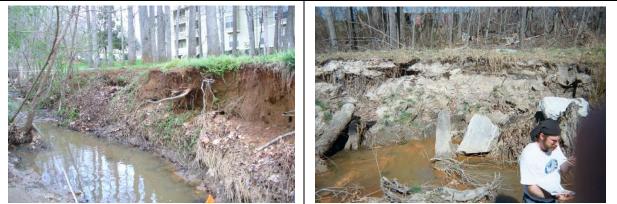
Figure 1: Visual Indicators Showing Failures in the Field for Protocol 1

Exposed Soil on Banks

Extreme Undercutting

Photo sources: clockwise from upper left, Tim Schueler and Josh Running

Some photos that show what visual indicators look like at problem sites can be found in Figures 1 and 2.

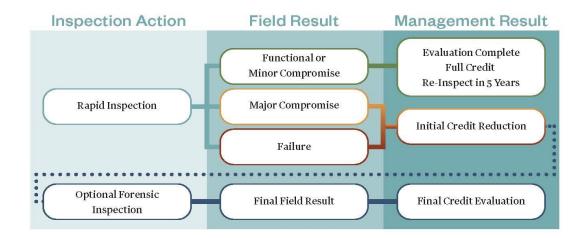
Figure 6: Flow Chart Relating Inspection Results to Management Actions

<i>C.</i> Compute Percent Function Loss Over Reach and Compare to Decision Thresholds in Table 7.			
Functioning or showing minor compromise	Project Failure	Showing Major Compromise	
 ¹ Restored bank length can be up to two times greater than the restored reach length ² Length of the hyporheic box along the channel from its initial disconnection extending downstream until connection is resumed, excluding bedrock sections,per design. ³ Area of floodplain with new or increased reconnection with the channel, per design ⁴ Calculated by dividing estimated linear feet of eroding/bare earth by the linear feet restored banks (e.g., 400 feet of eroded bank observed over a 1,000 feet restoration project would be 400/2000=20%). ⁵ Done in the same general manner as Protocol 1 ⁶ Can be measured as % bank height length exceeding design tolerances or % floodplain area not vegetated or otherwise connected

Figure 6 presents a flow chart that outlines the process for making management decisions when a project exceeds its given thresholds.

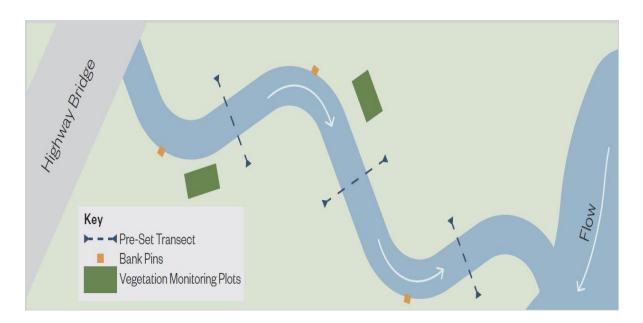
Figure 7: Concept of how key protocol data is shown on post-construction project plans

- Depending on the project design, all post-construction plans should clearly demarcate the following features:
 - Locations and extent of the restored banks and riffles
 - Design limits of the hyporheic box and/or reconnected floodplain, if used
 - Locations and elevations for bank height measurement stations
 - Any other locations for bank pins, random checks of floodplain or hyporheic box, or vegetative cover plots needed to evaluate the project (see Figure 7).
- Post-construction plans should identify fixed photo stations or cross-sections along the project reach. If possible, these should be monumented at reach locations to facilitate measurement. Designers should emphasize vulnerable
